ADVANCED METALLIC AIR VEHICLE STRUCTURE PROGRAM

GENERAL DYNAMICS
FORT WORTH DIVISION

JUNE 1975

FOURTH INTERIM REPORT ✓
TECHNICAL REPORT AFFDL-TR-75-40

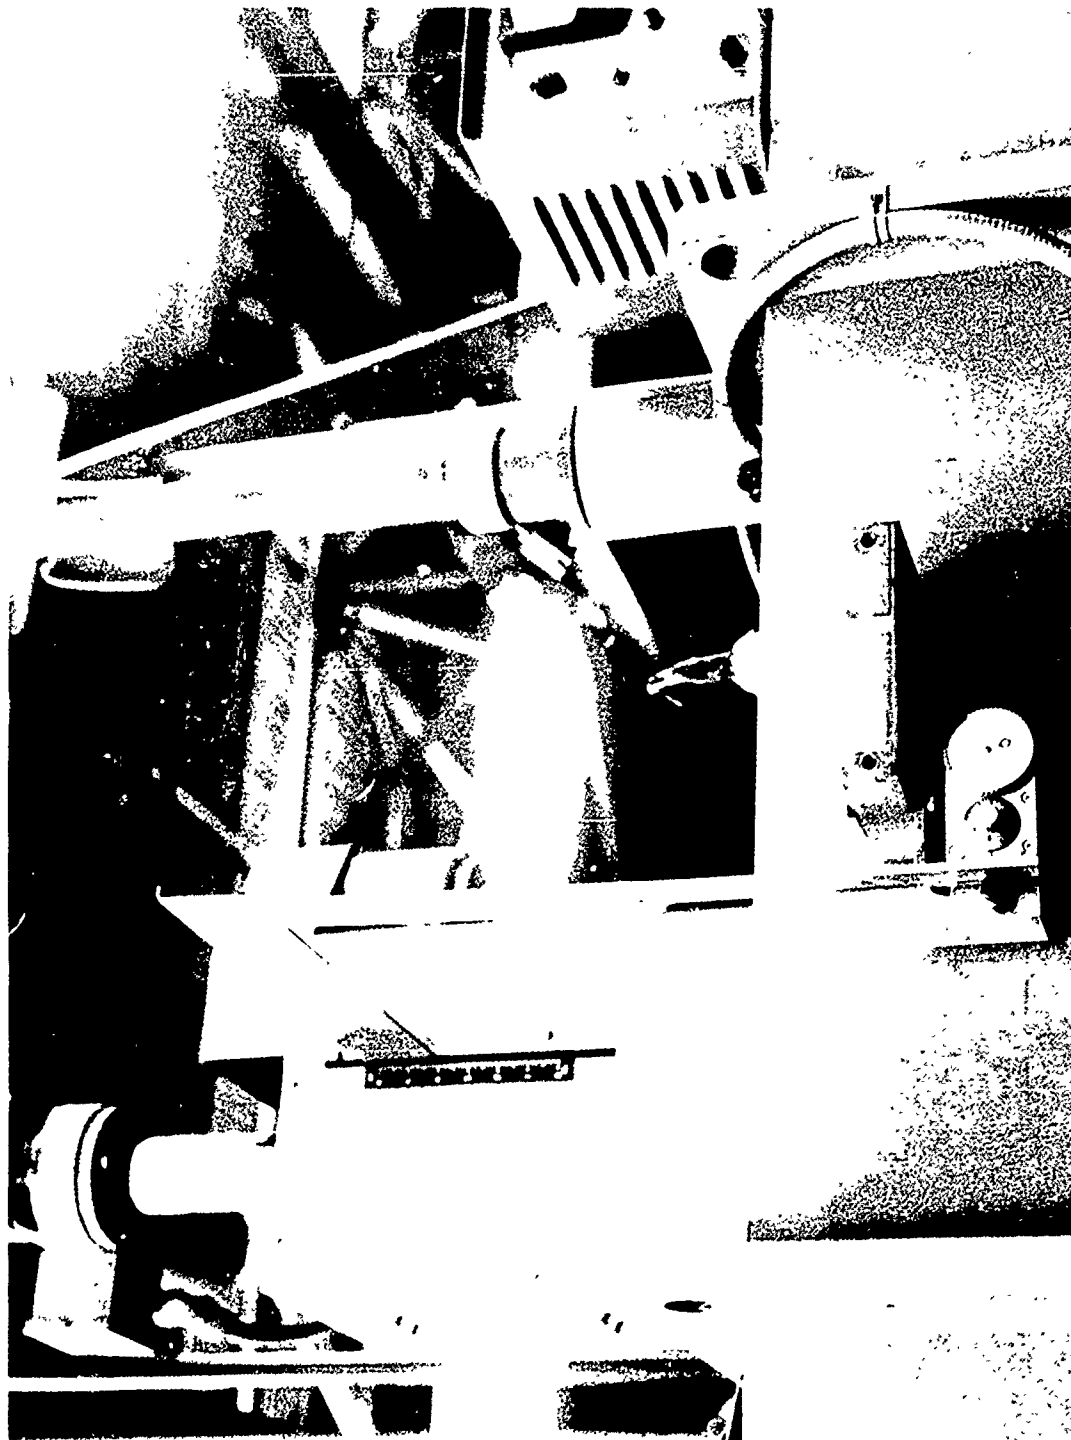
Figure 4.1.5-16 TRAV-O-DIAL - PRECISION VERNIER FOR SETTING
EB GUN TO WORK DISTANCE TO ± 0.005 "

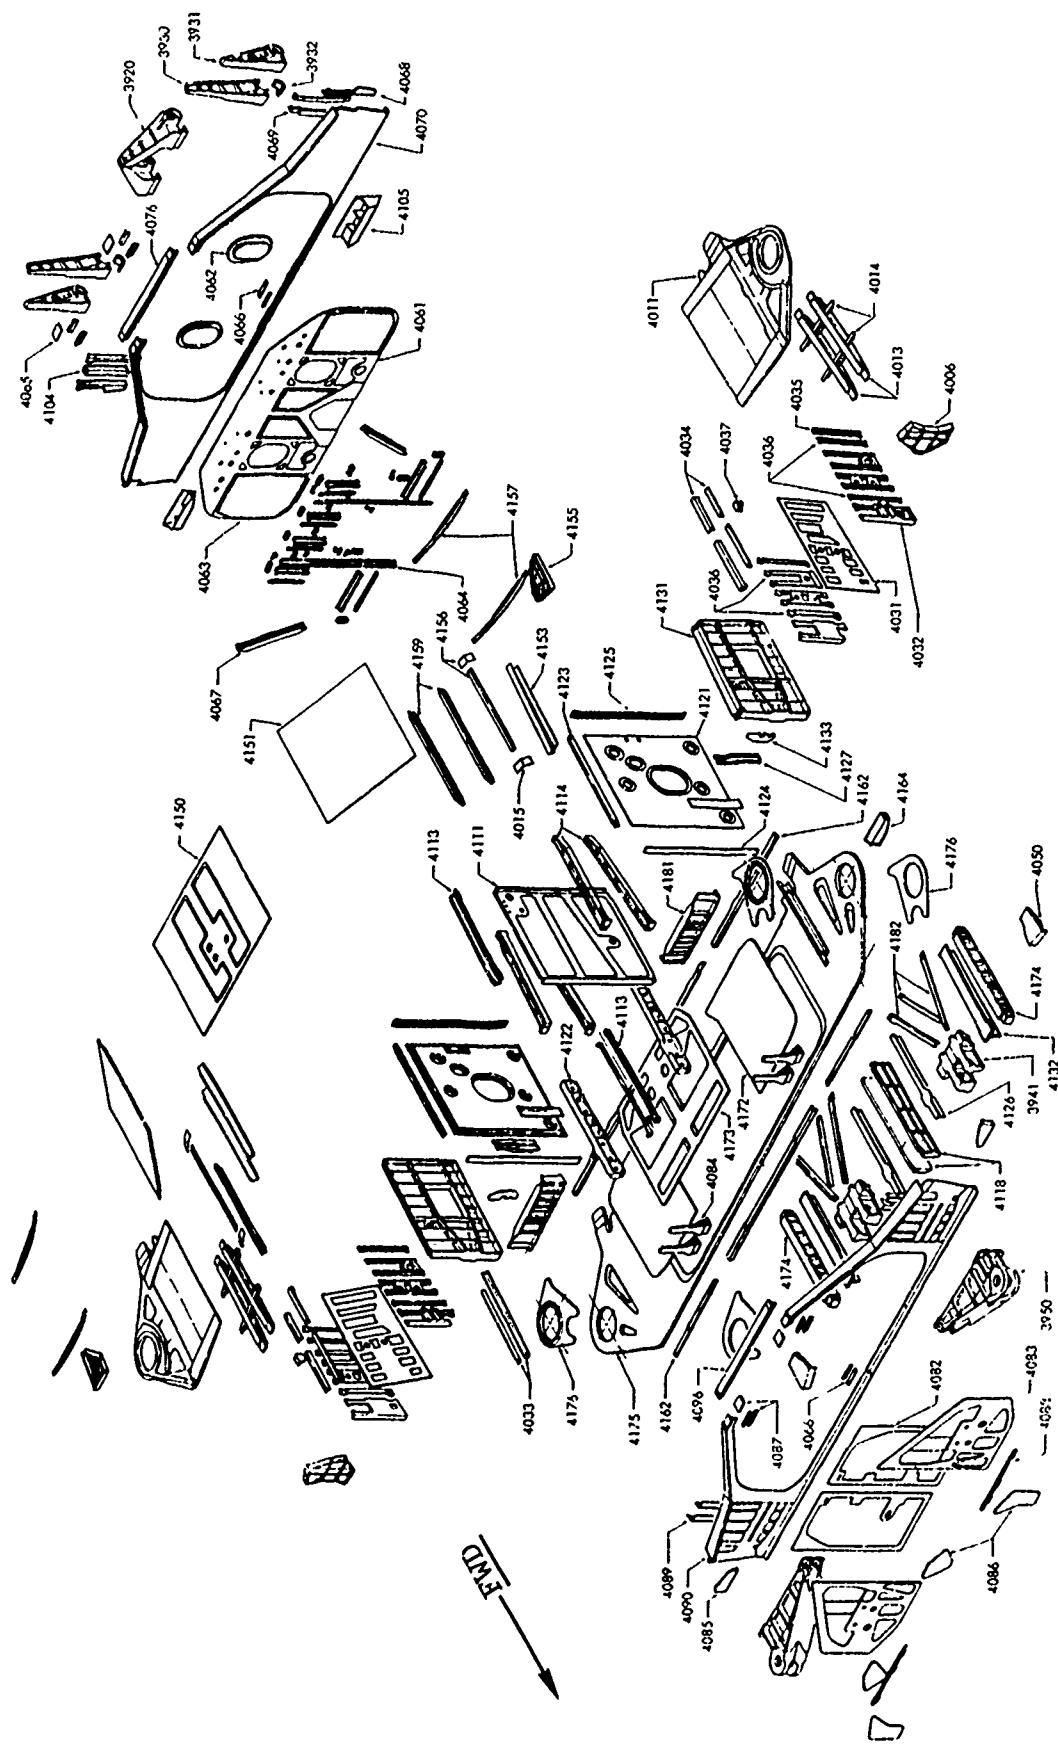
Figure 5.1-1 X7224001. WCTS MANUFACTURING BREAKDOWN

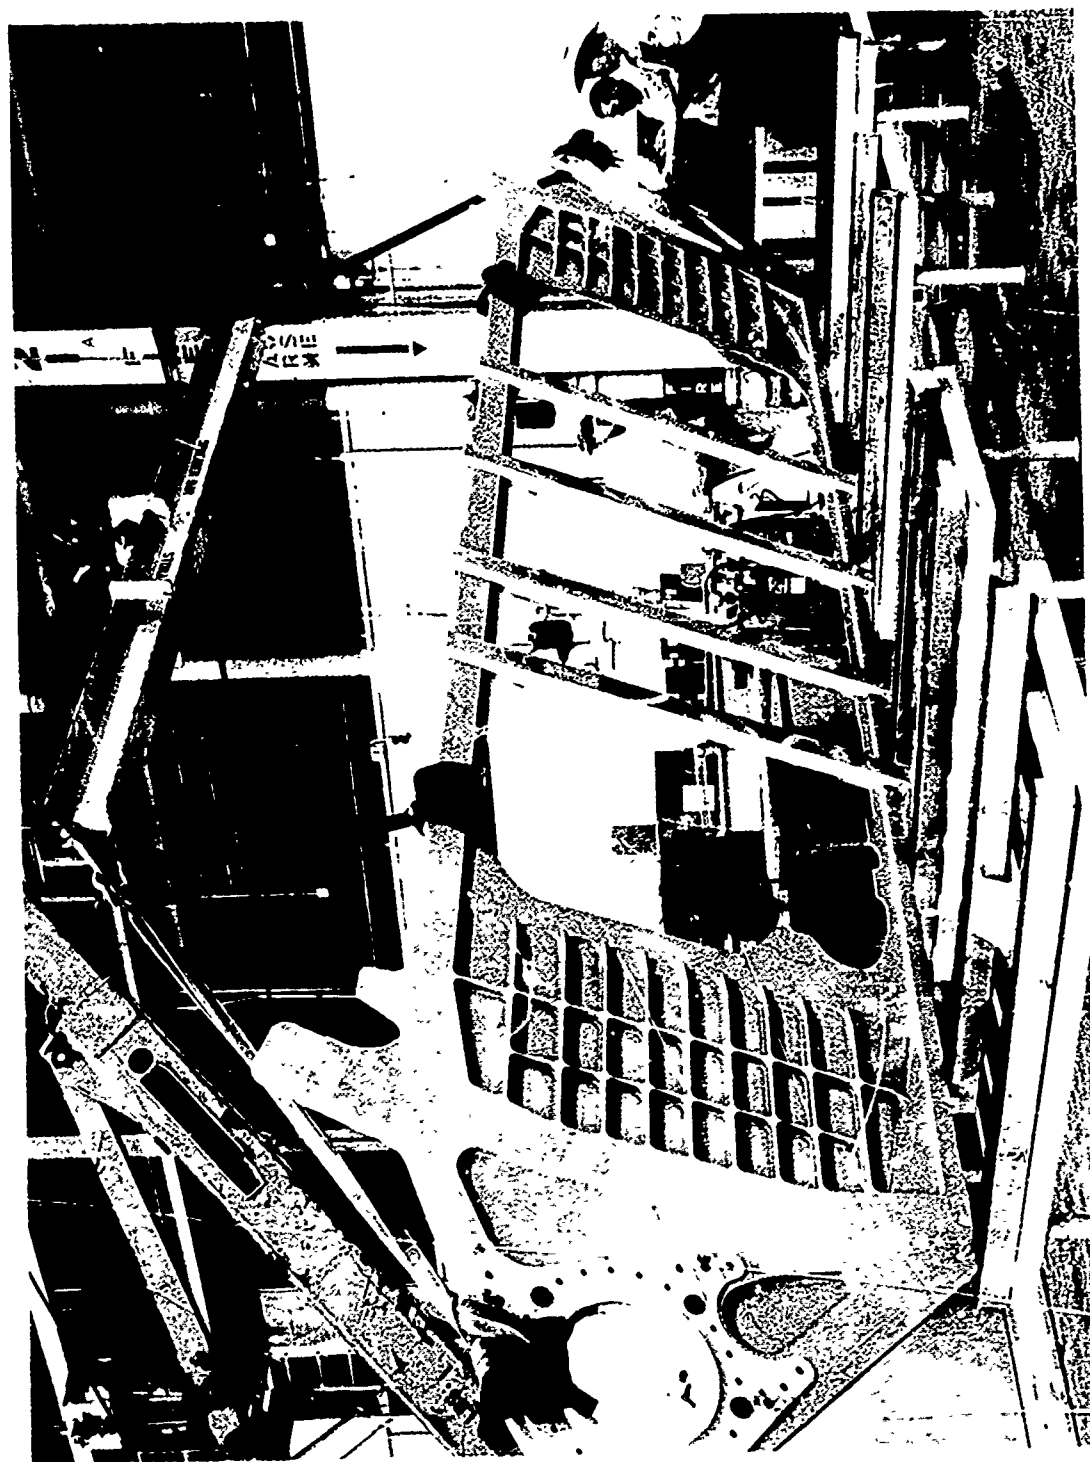
Figure 5.1.1-2 REINFORCING LUGS ATTACHED TO LOWER PLATE
WITH SET-UP BOLTS

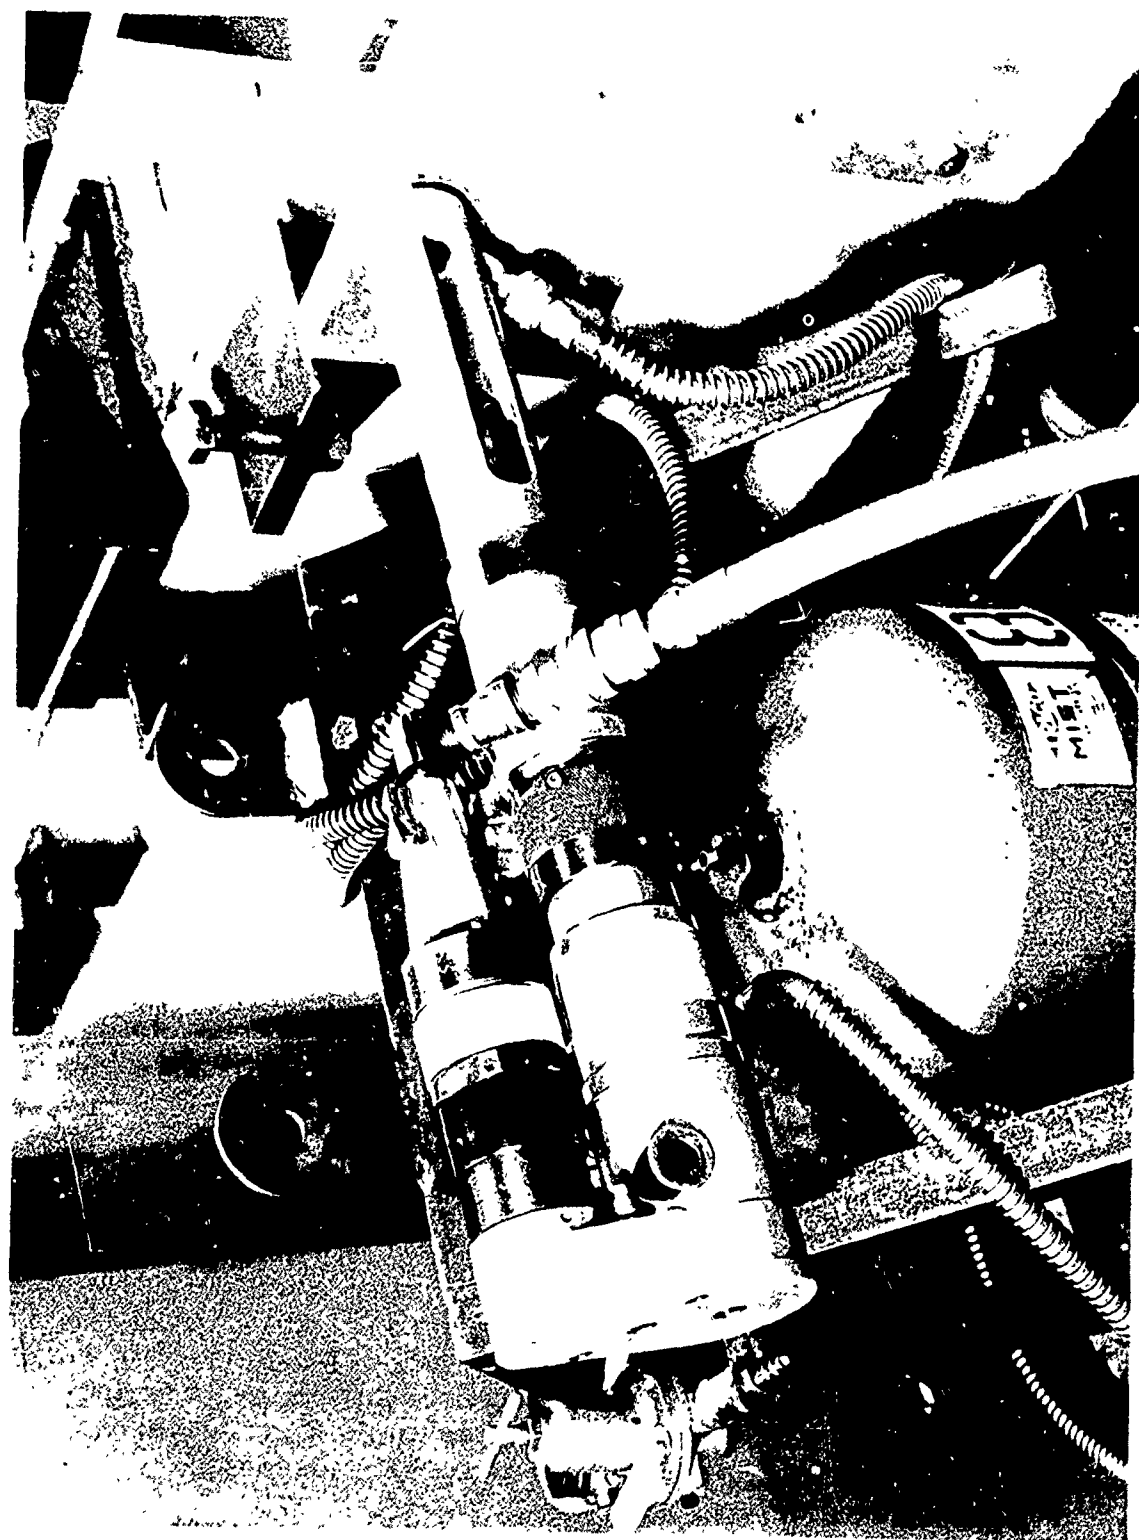
Figure 5.1.1-4 QUACKENBUSH DRILL UNIT FOR LOWER PLATE DRILLING

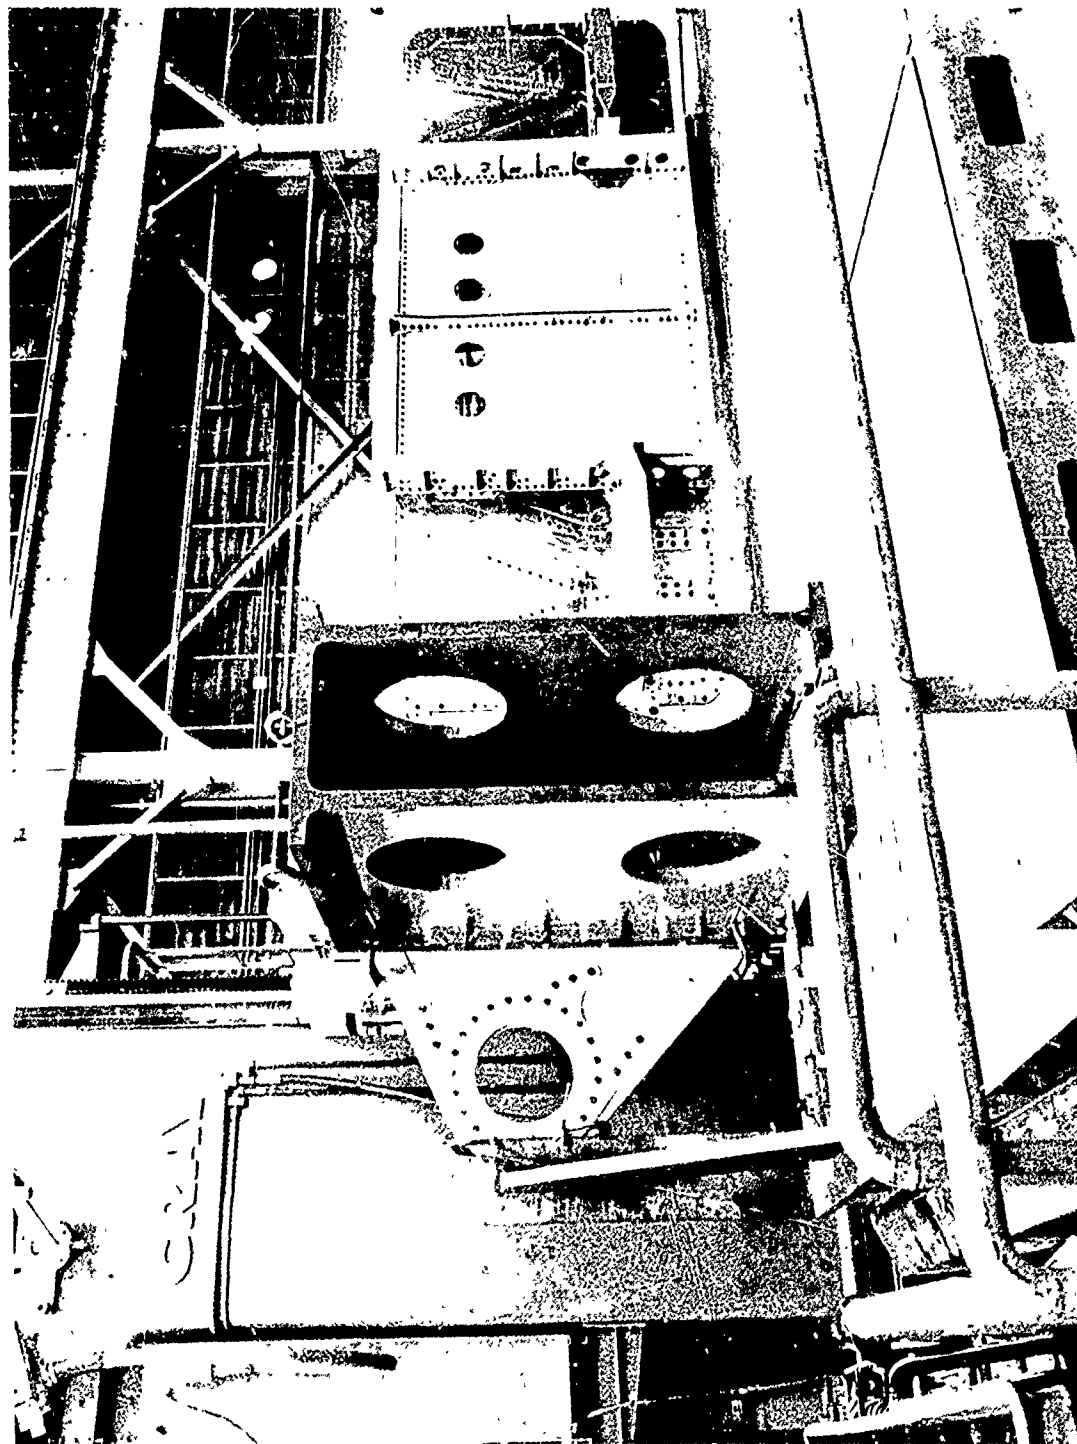
Figure 5.1.1-5 LOWER PLATE ASSEMBLY ON GRAY BORING MILL

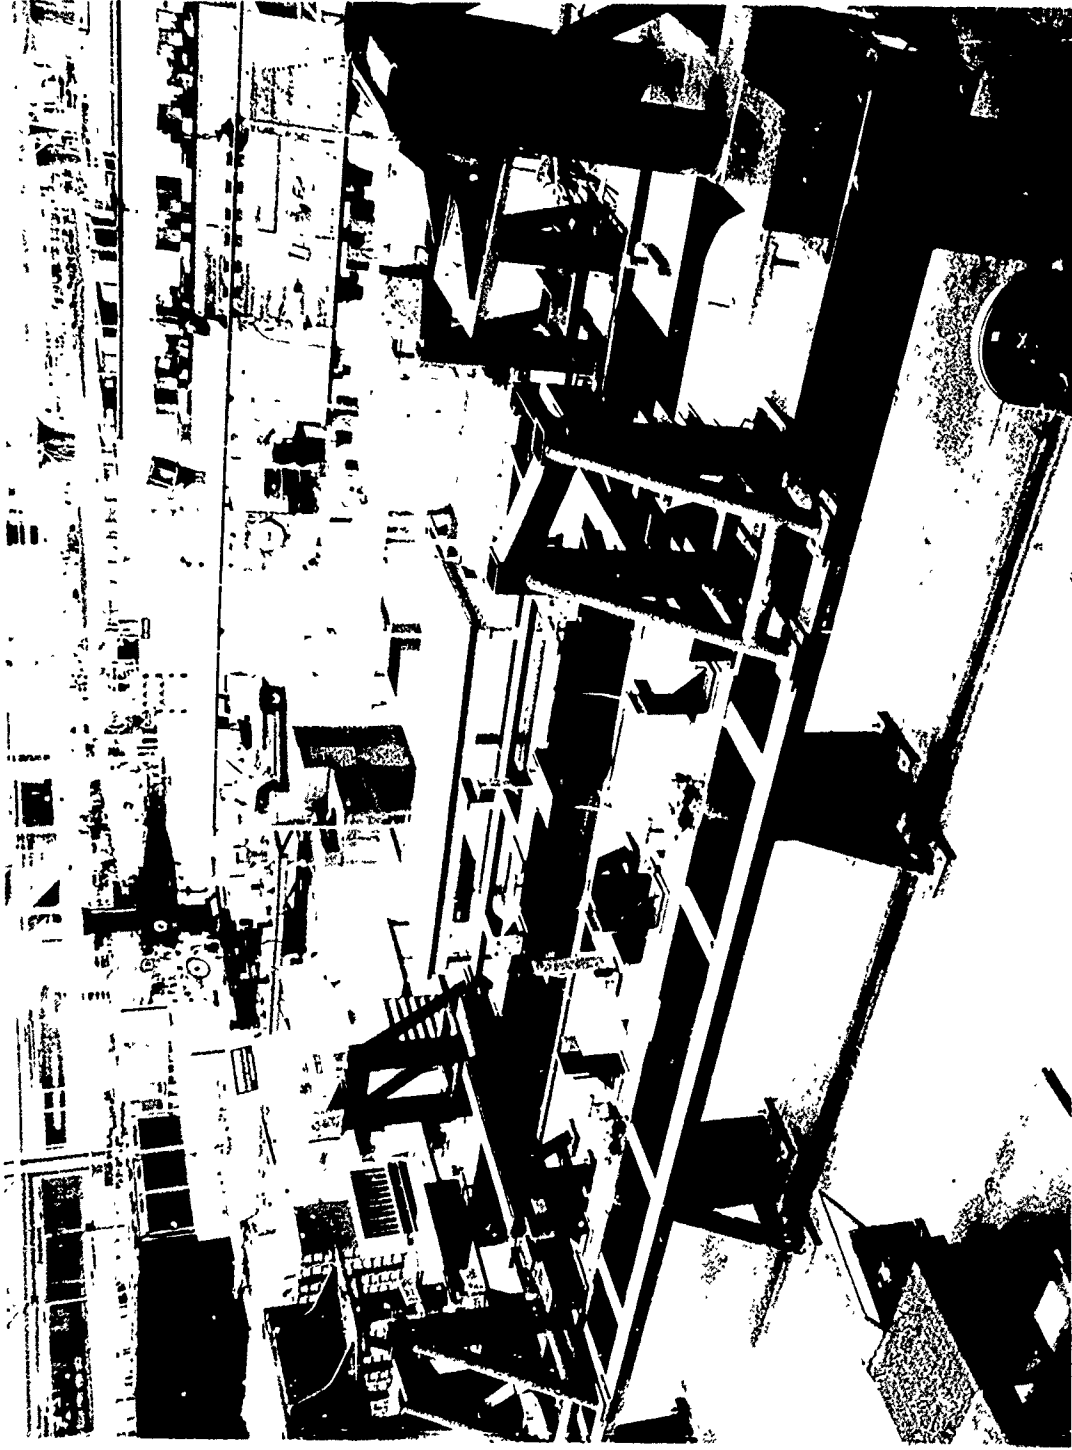
Figure 5.1.2-1 MAJOR ASSEMBLY FIXTURE - FINAL ASSEMBLY

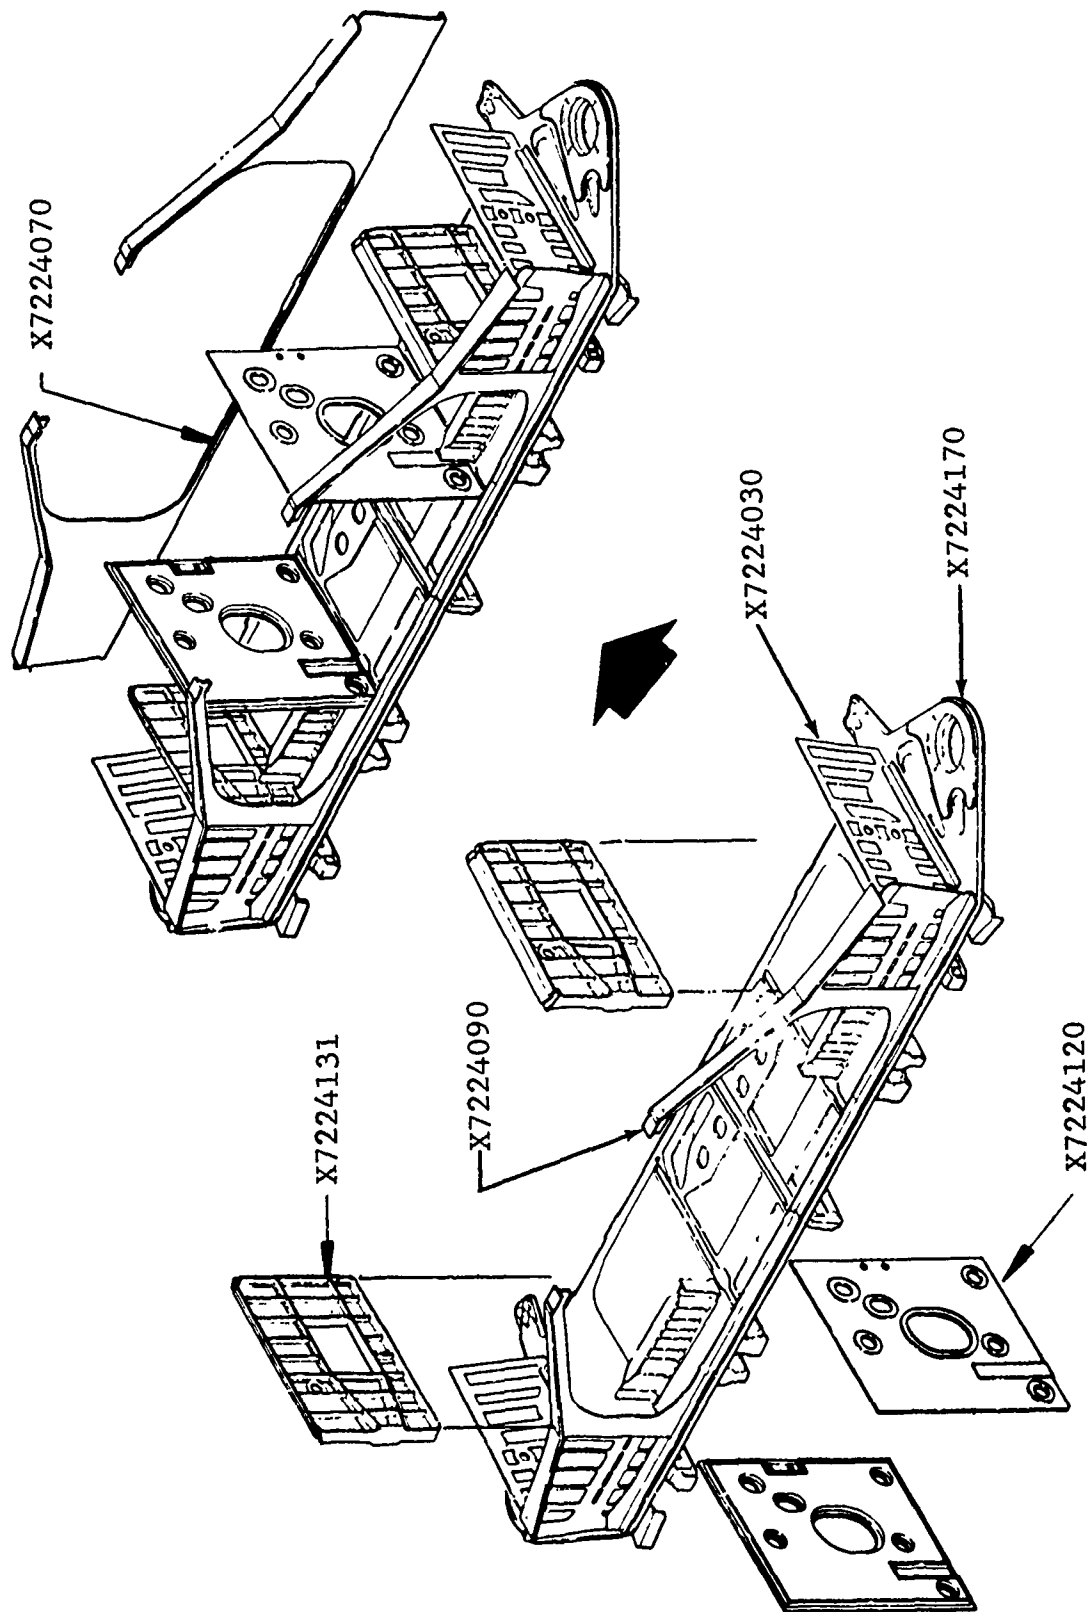
Figure 5.1.2-5 PREFIT AND SET-UP - X_F39 AND X_F84
RIBS AND AFT BULKHEAD SEGMENTS

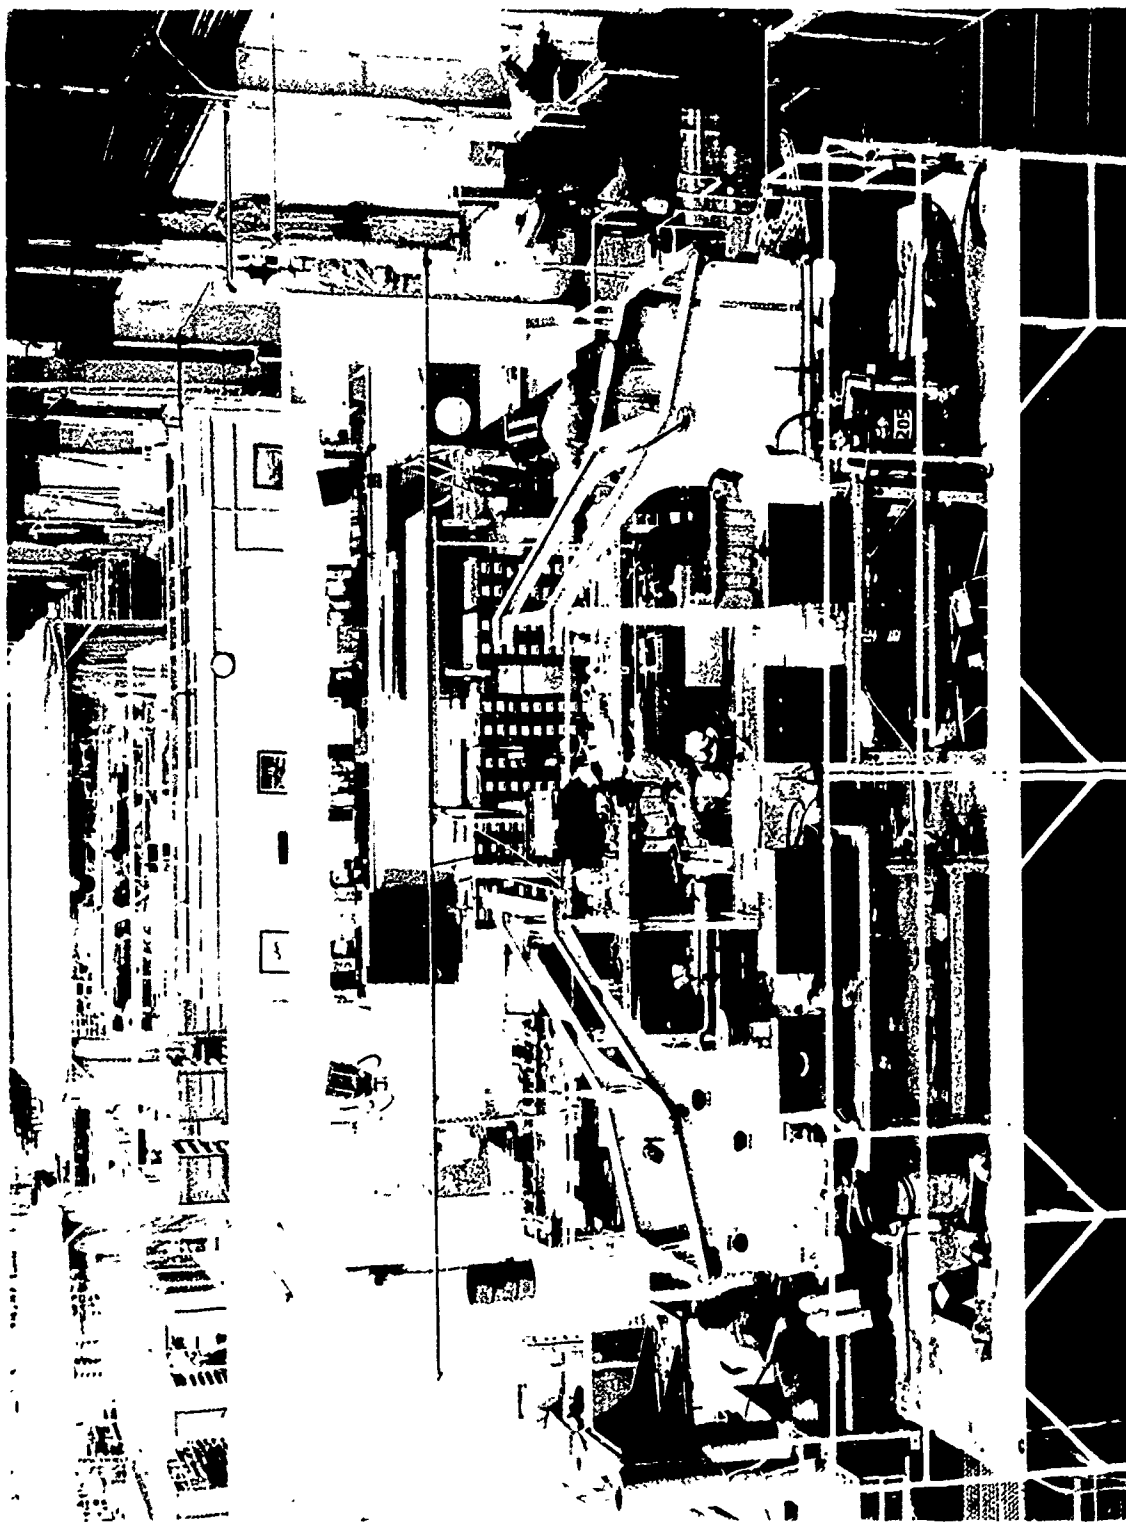
Figure 5.1.2-6 INSTALLATION OF PREFIT COMPONENTS

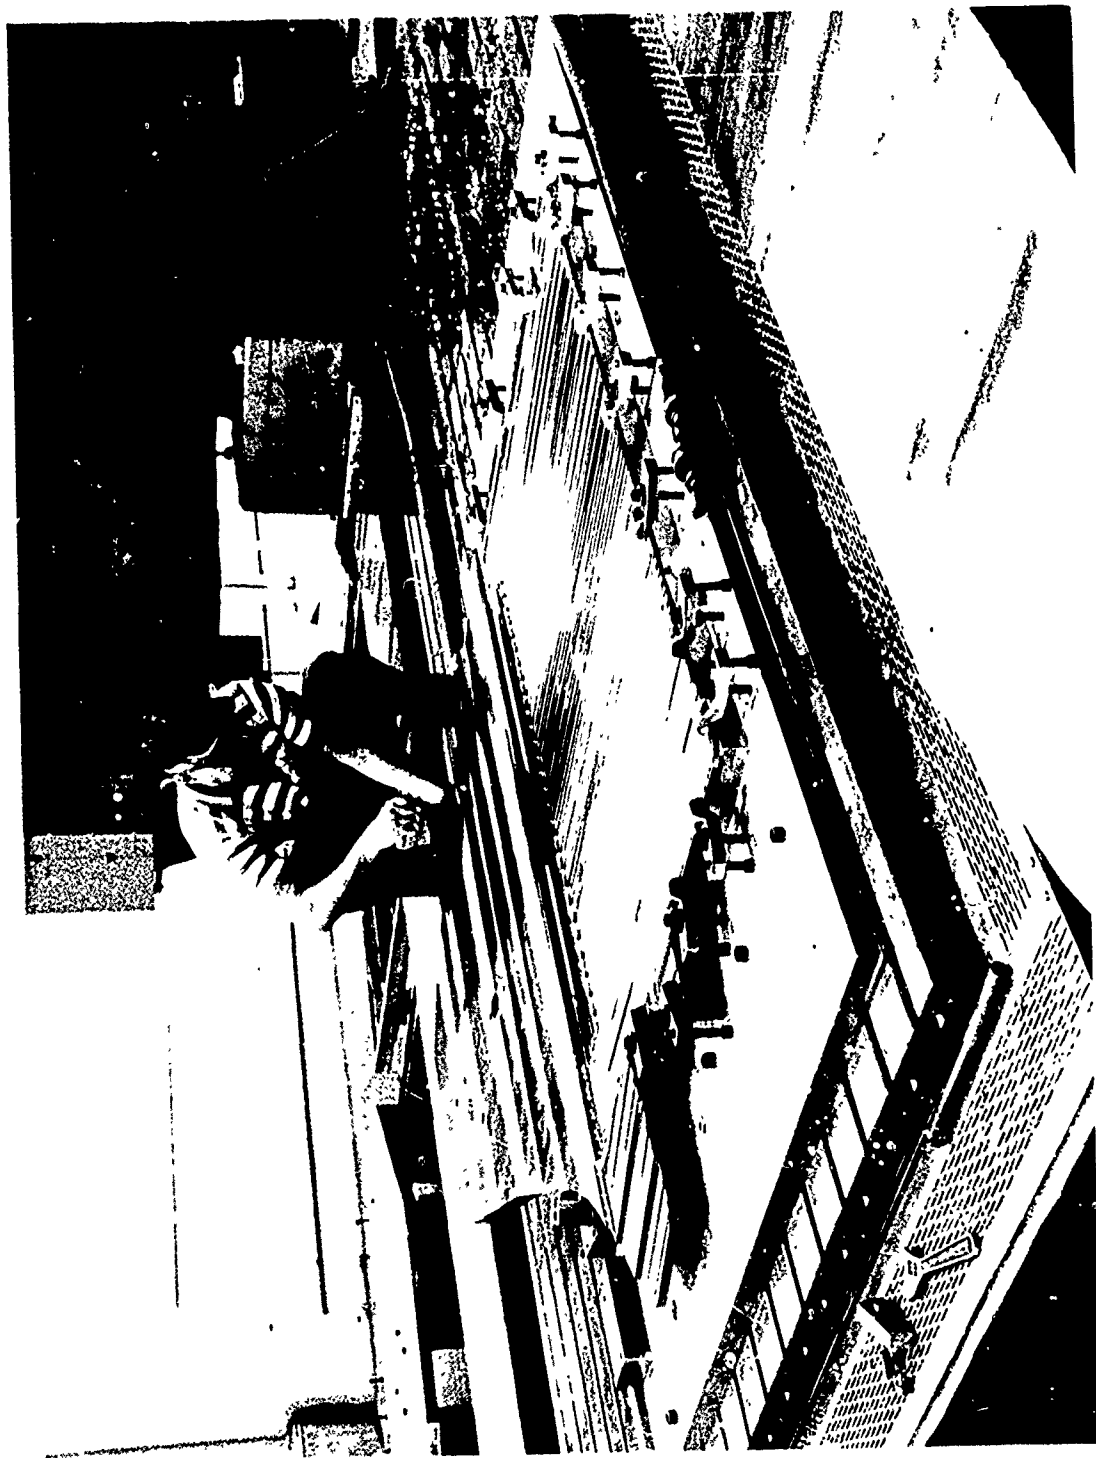
Figure 5.1.2-11 SET-UP FOR N. C. MACHINING OF UPPER LUG

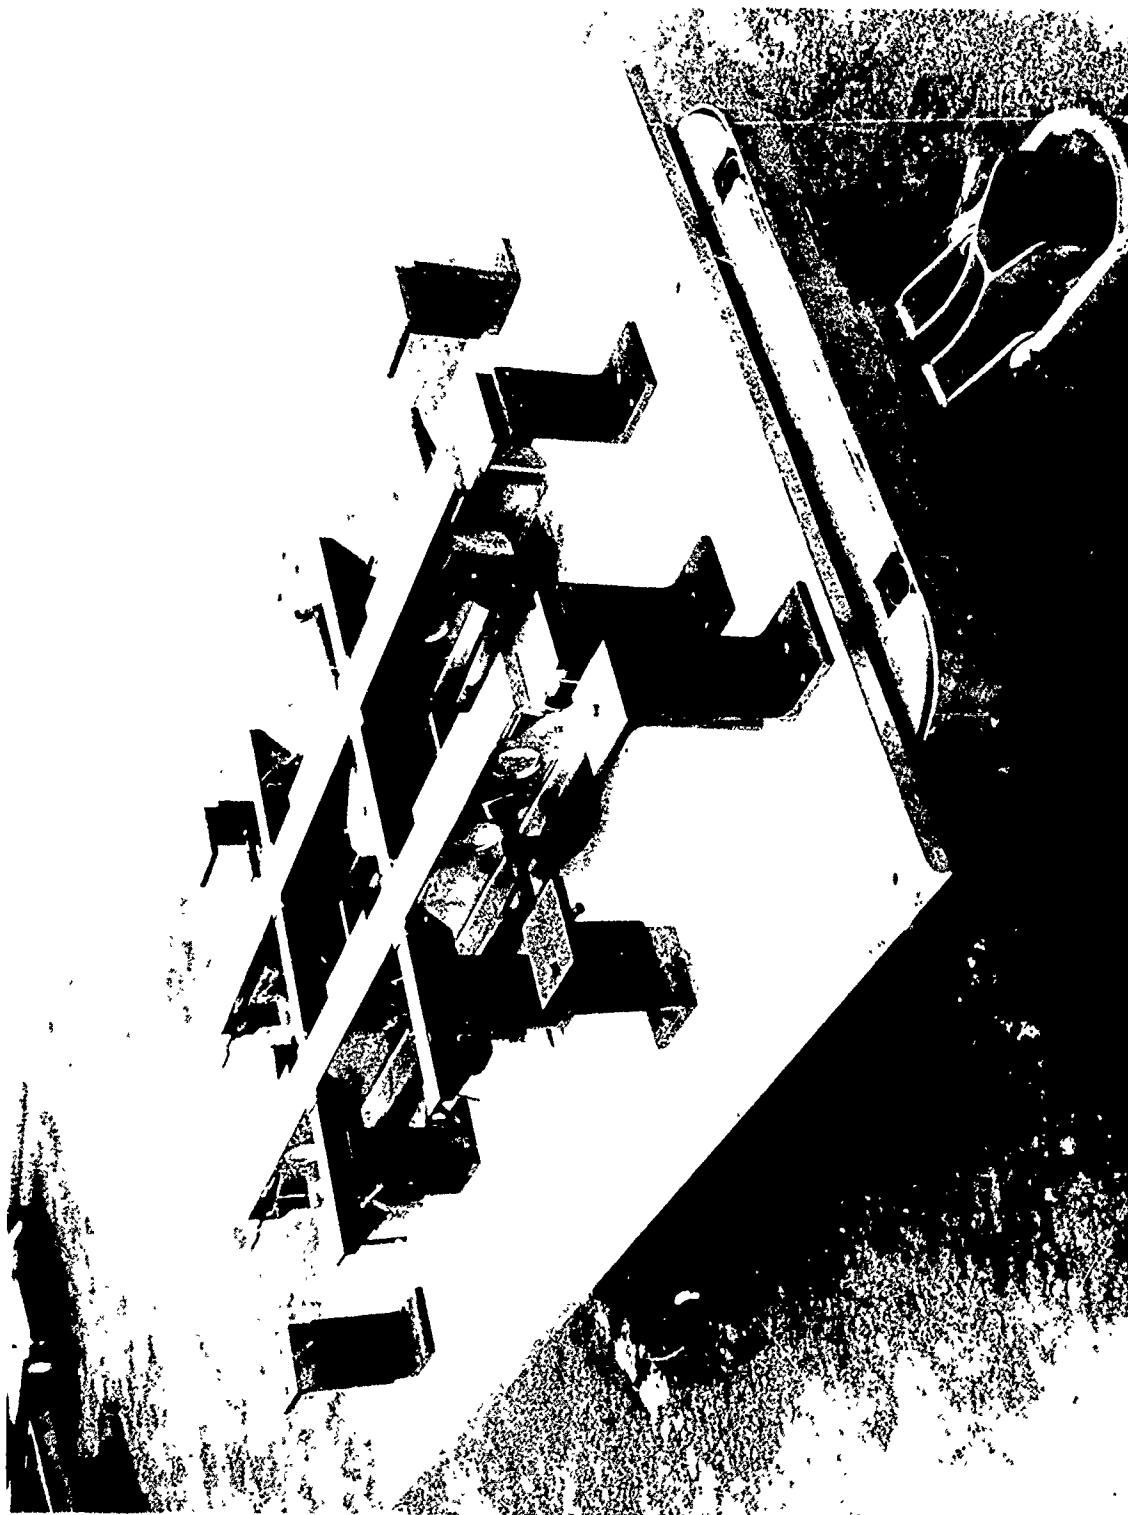
Figure 5.1.2-13 N.C. DRILLING FIXTURE FOR UPPER LUG ASSEMBLY

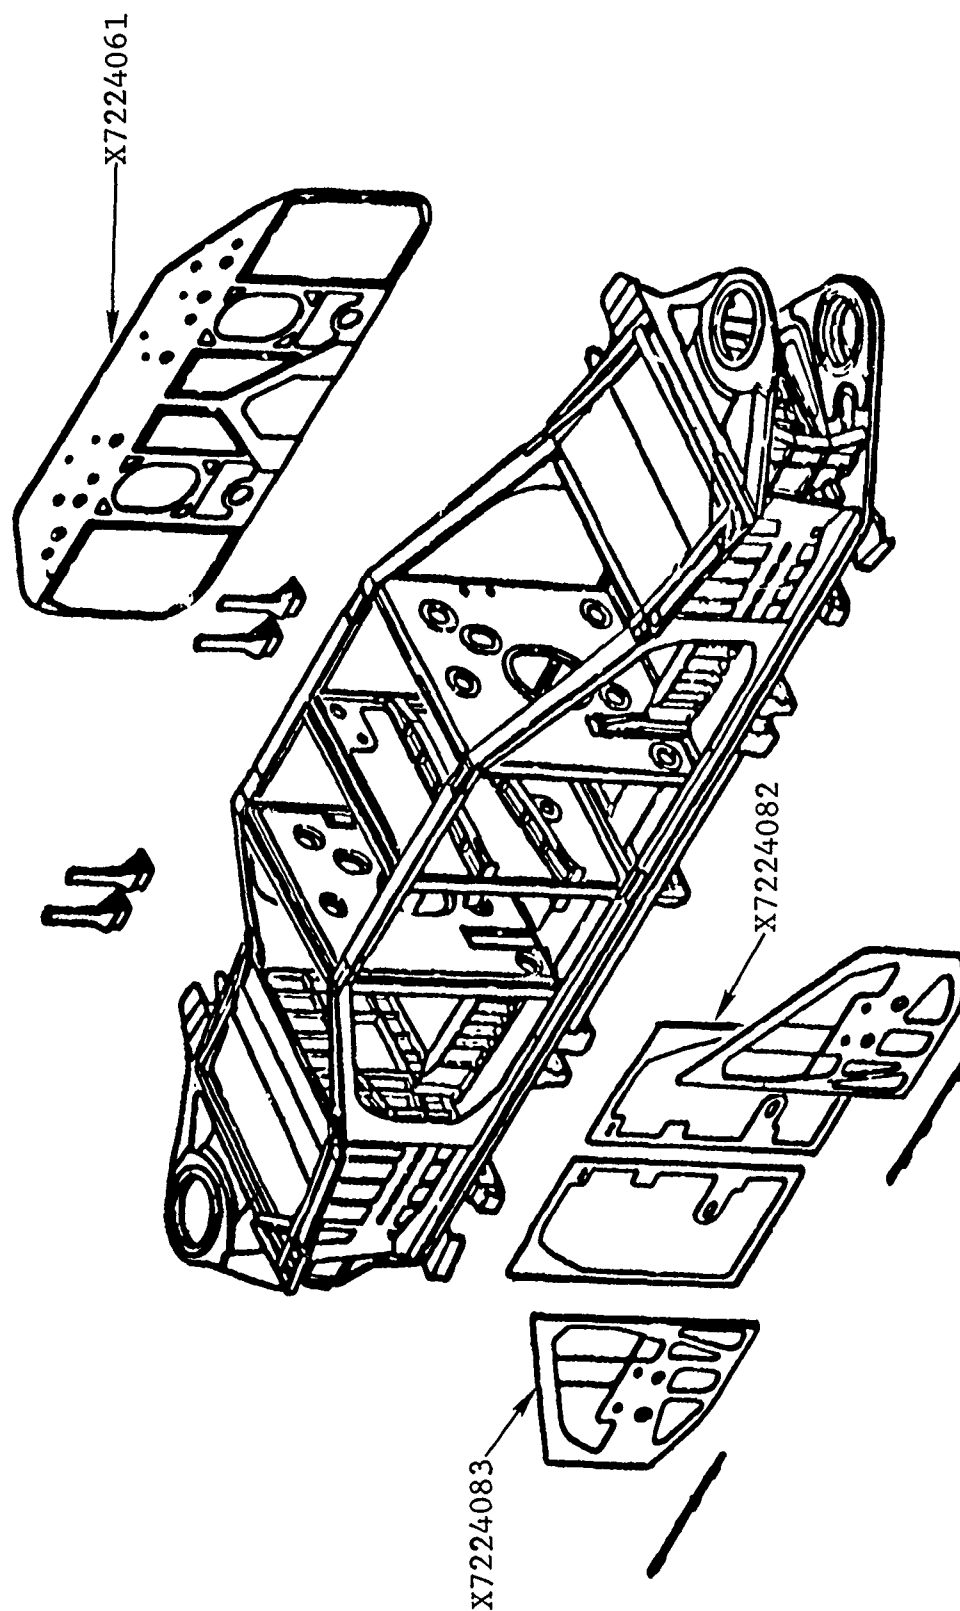
Figure 5.1.2-14 EXPLODED VIEW SHOWING FORWARD AND AFT BULKHEAD BONDED PANELS

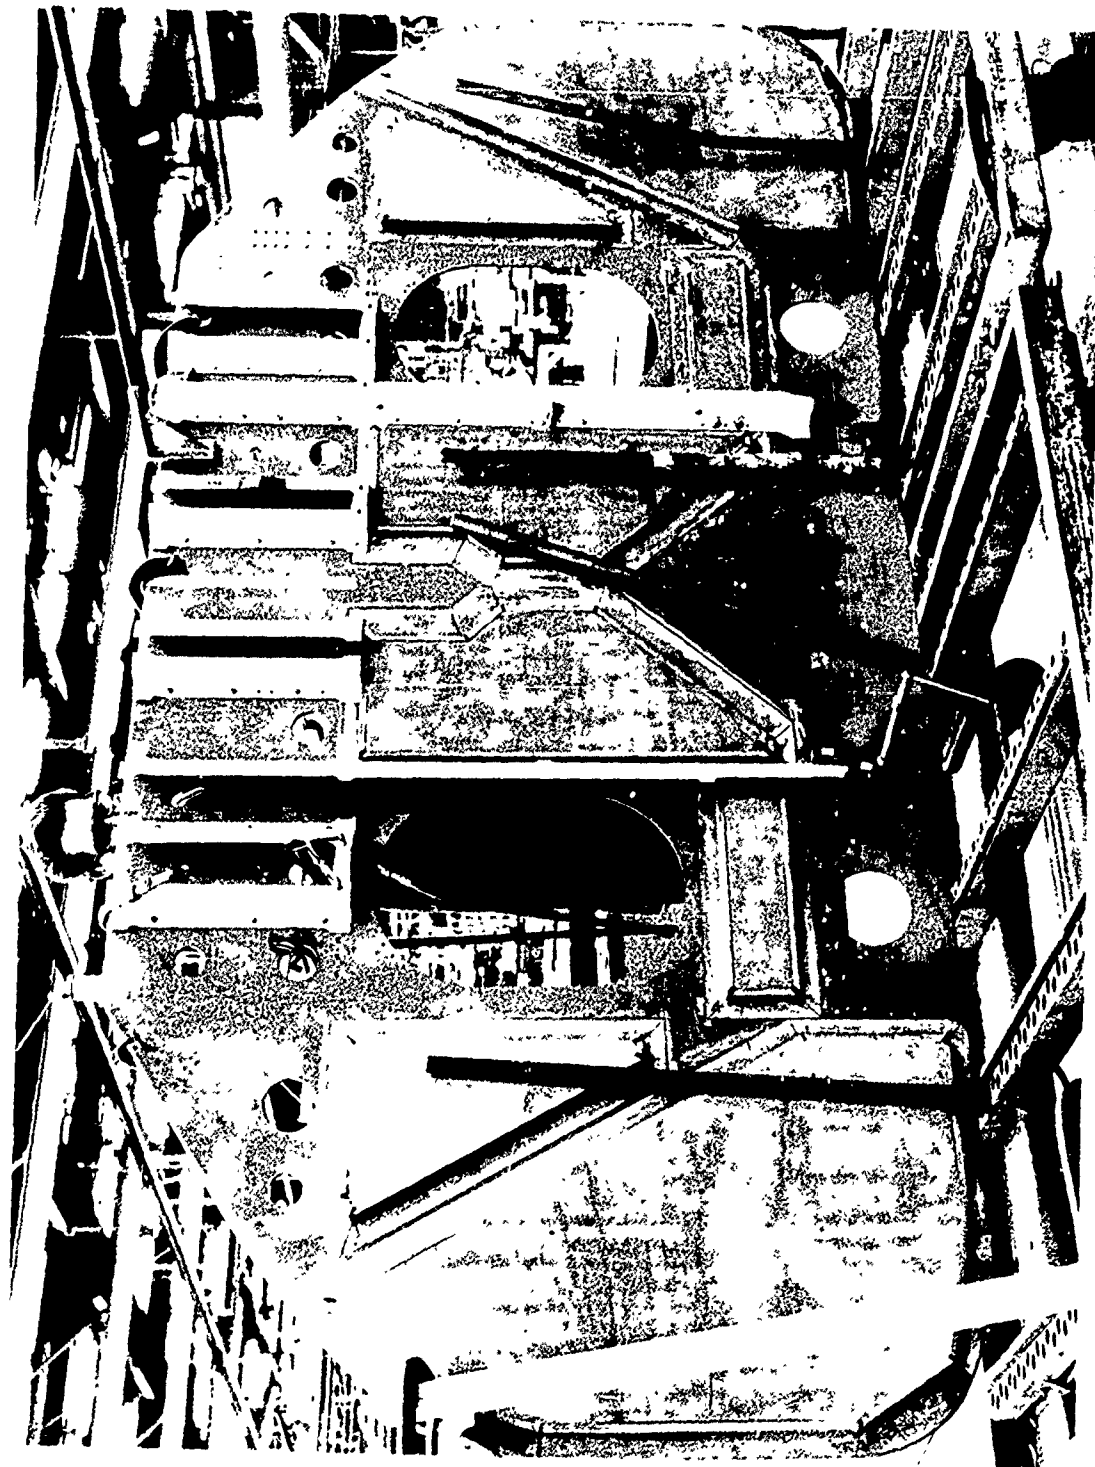
Figure 5.1.2-15 X7224061 BONDED TITANIUM PANEL ASSEMBLY

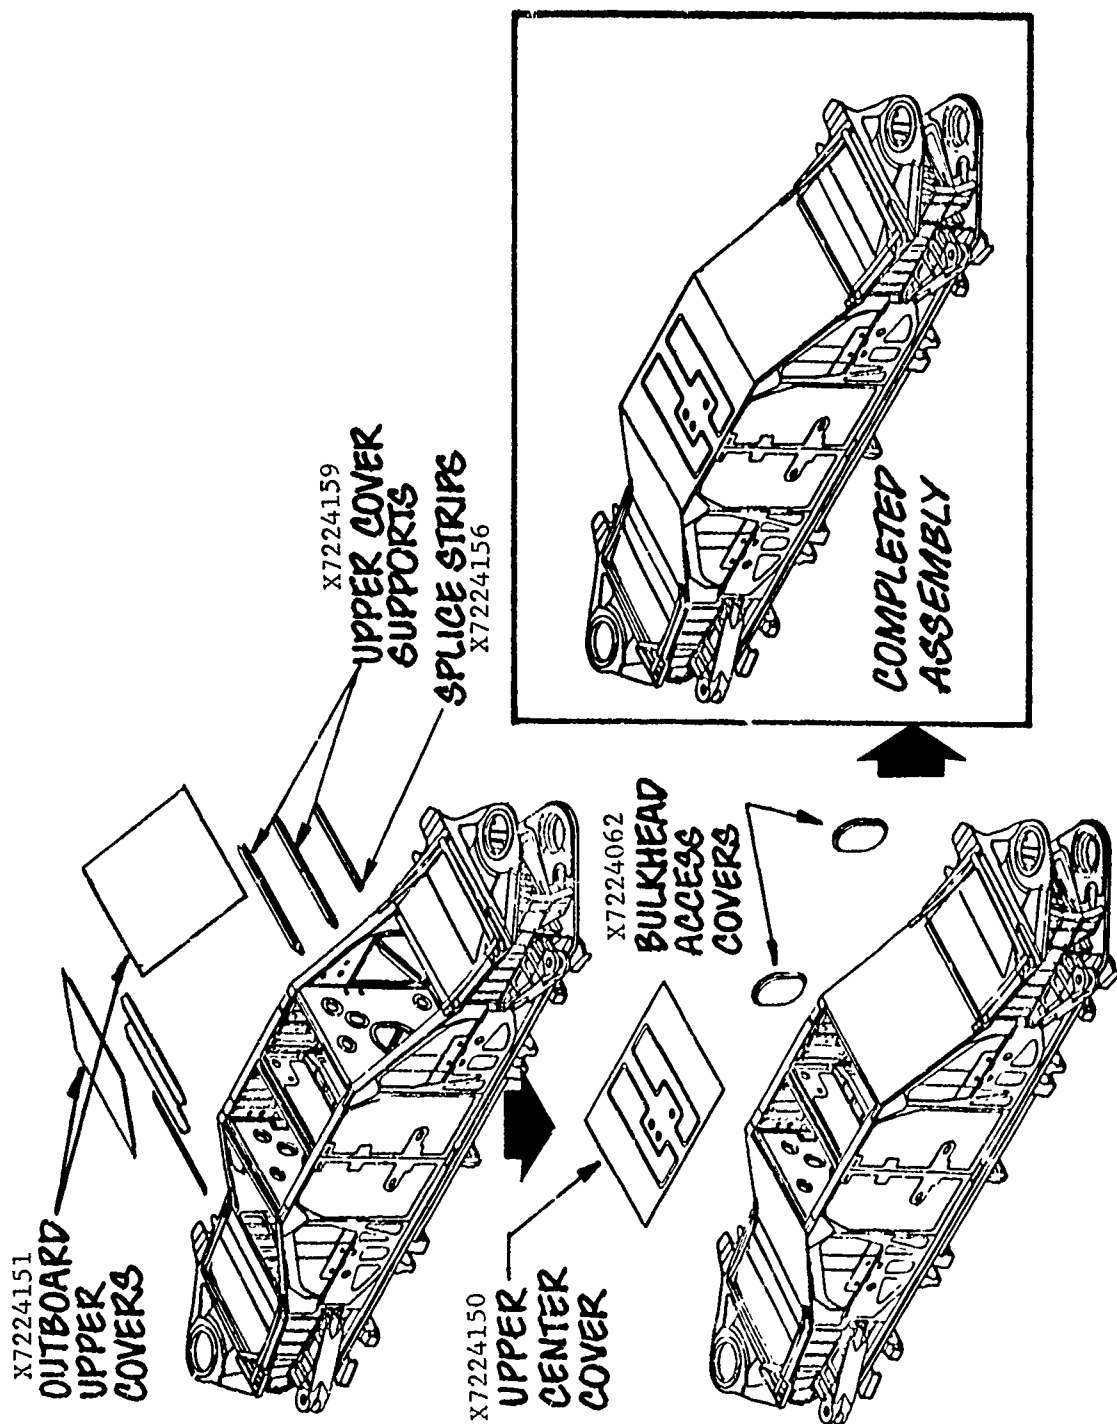
Figure 5.1.2-16 INSTALLATION SEQUENCE OF UPPER COVERS AND AFT ACCESS DOOR

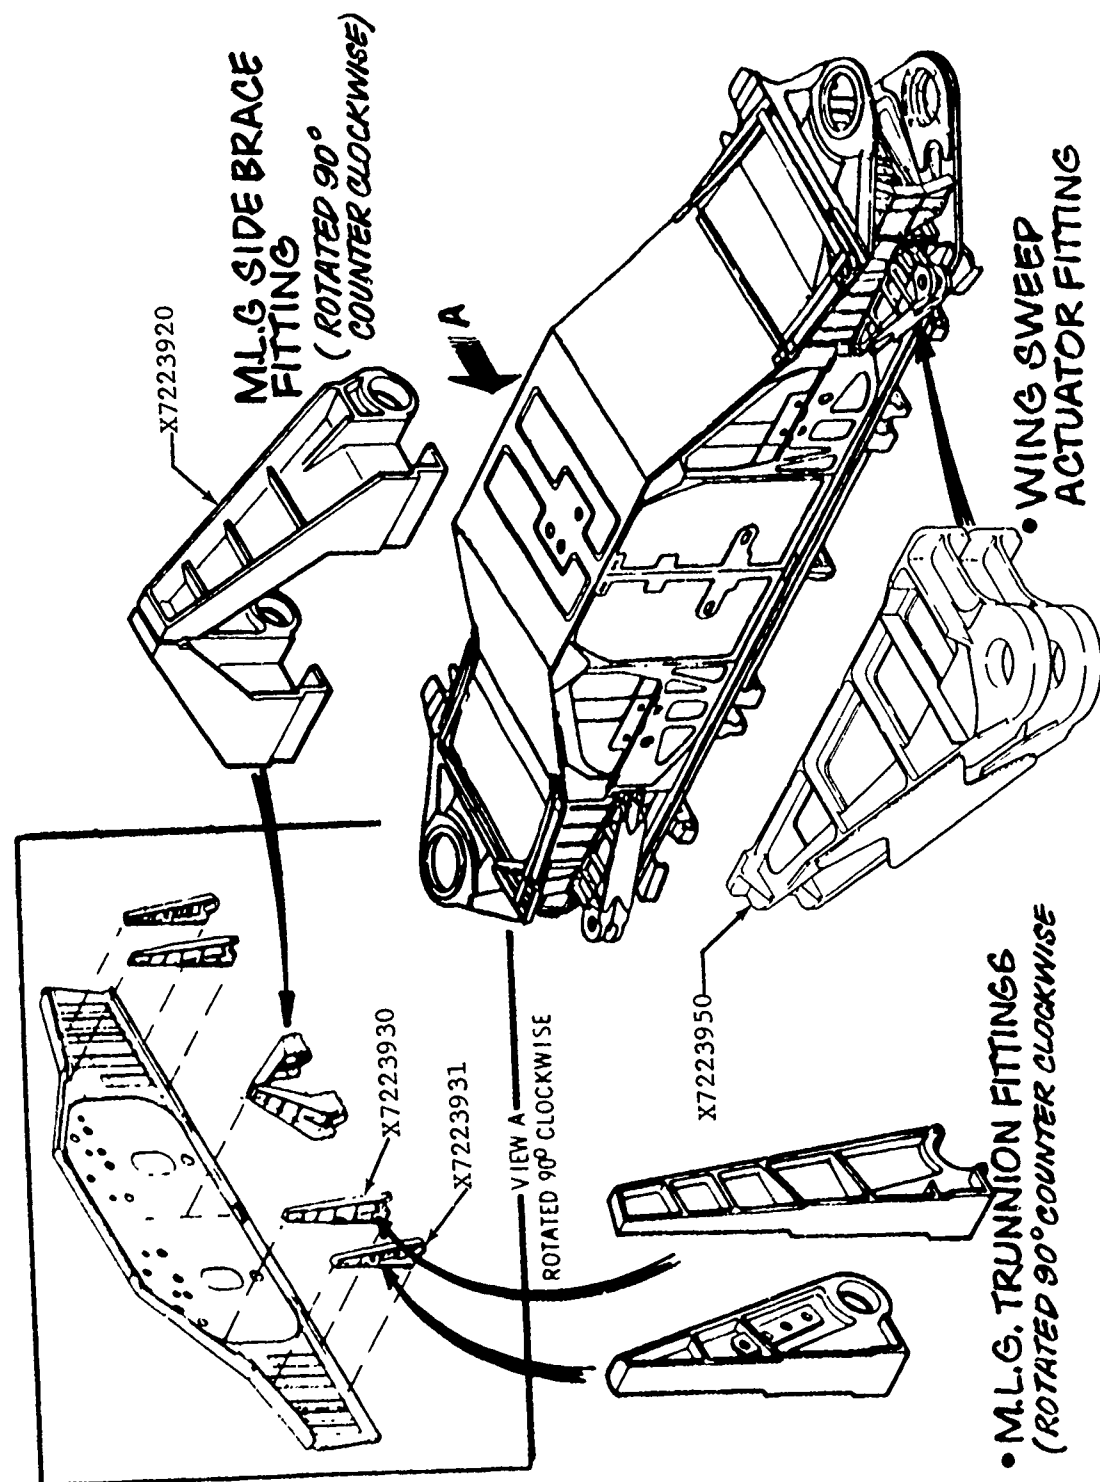
Figure 5.1.2-17 INSTALLATION OF LANDING GEAR FITTING AND WING SWEEP ACTUATOR FITTINGS
